**ENHANCED PRELIMINARY ASSESSMENT REPORT  
FOR TOOEELE ARMY DEPOT - NORTH AREA  
TOOELE, UTAH**

**AGEISS ENVIRONMENTAL, INC.  
1900 Grant Street, Suite 1130  
Denver, Colorado 80203**

**October 5, 1994**

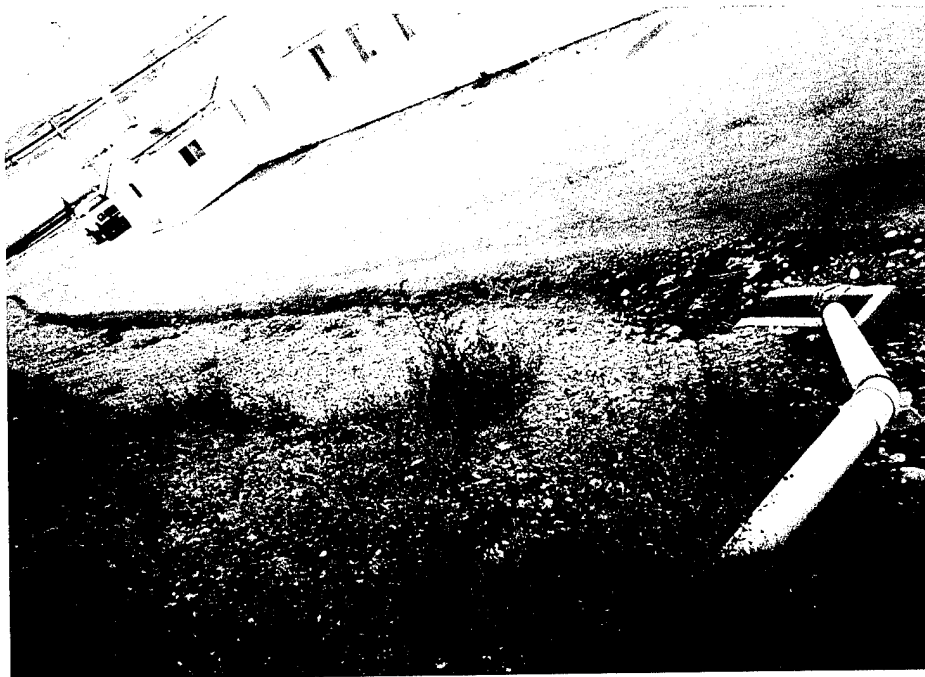
Photograph 1. (AREE 1a - Current Stormwater Sewer System). View Southwest of Storm Drainage Outfall Near Building 614.

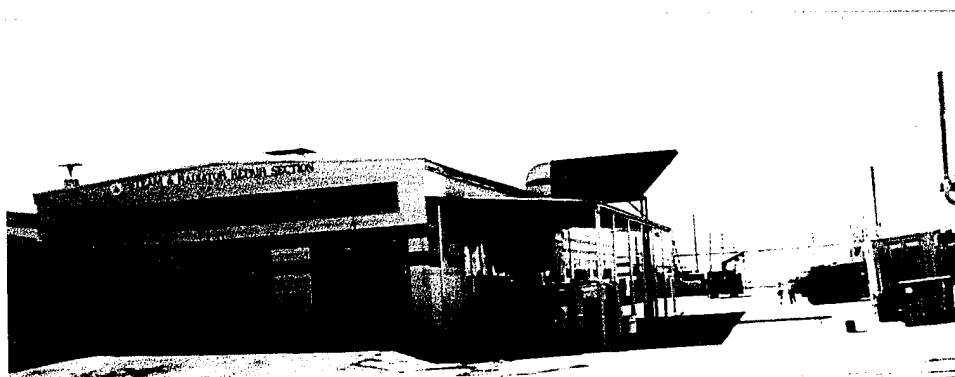
Photograph 2. (AREE 1c - Radiator Repair Facility). View of the Radiator Repair Facility in Building 609.

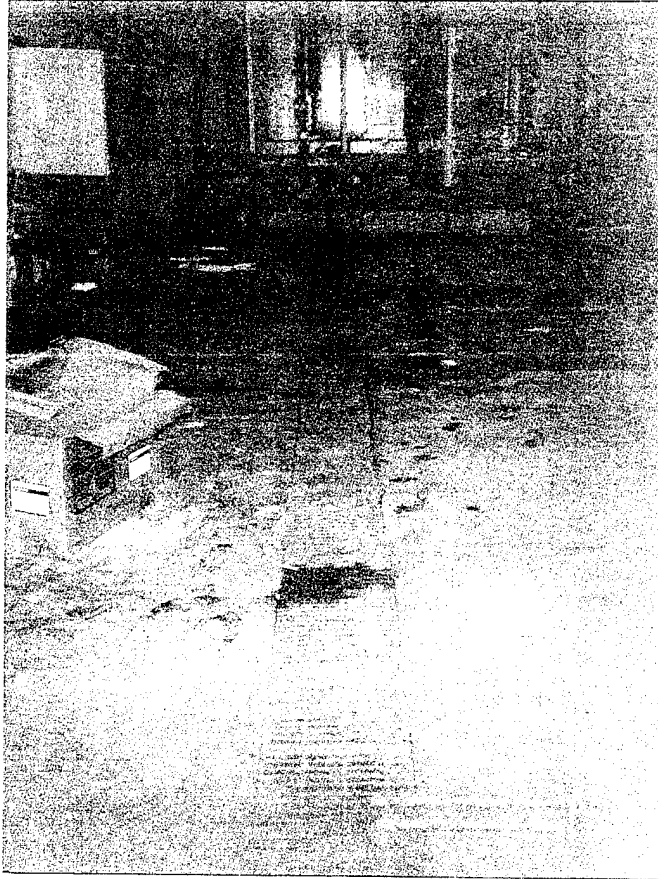
Photograph 3. (AREE 2 - SWMU 47: Boiler Plant Blowdown Water). View of Boiler Blowdown Sump in Building 637.

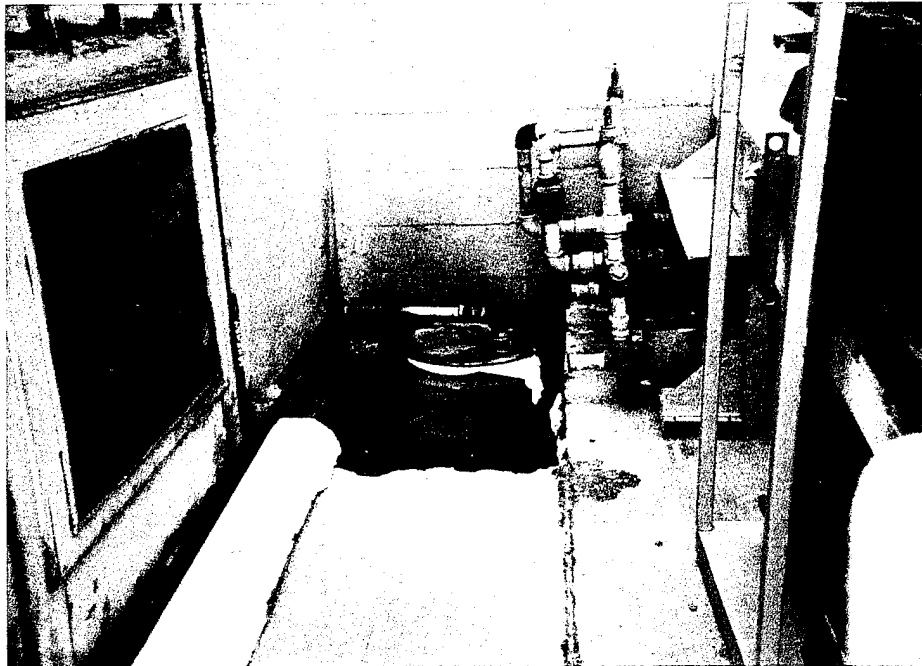
Photograph 4. (AREE 3 - Compressor Condensate Drain). View East of Compressor Condensate Drainage System Outside Building 619.

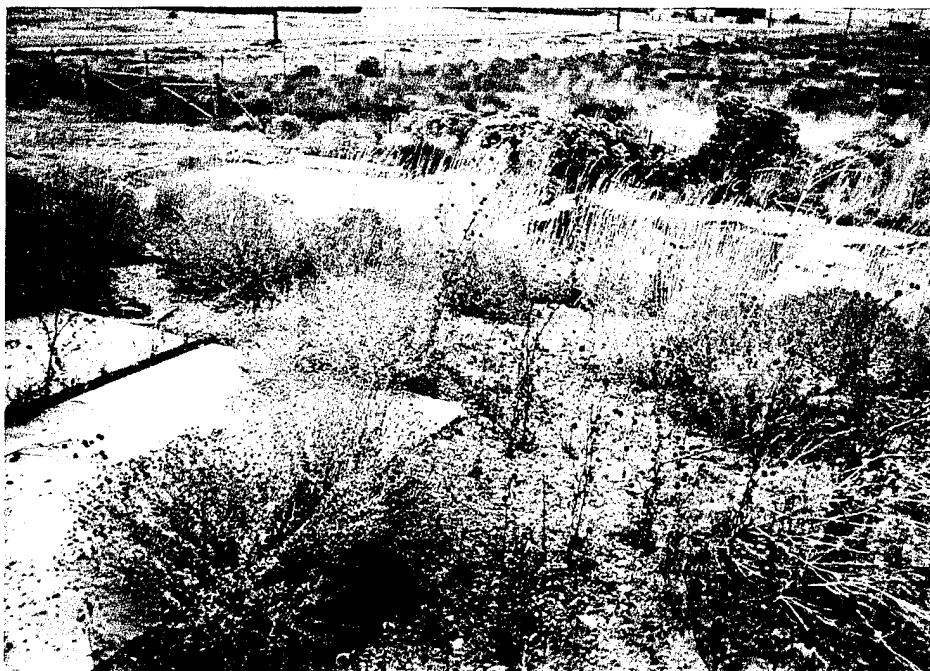
Photograph 5. (AREE 4 - SWMU 51: Chromic Acid/Alodine Drying Beds). View Northwest of Chromic Acid/Alodine Drying Beds Marked as Building 623.

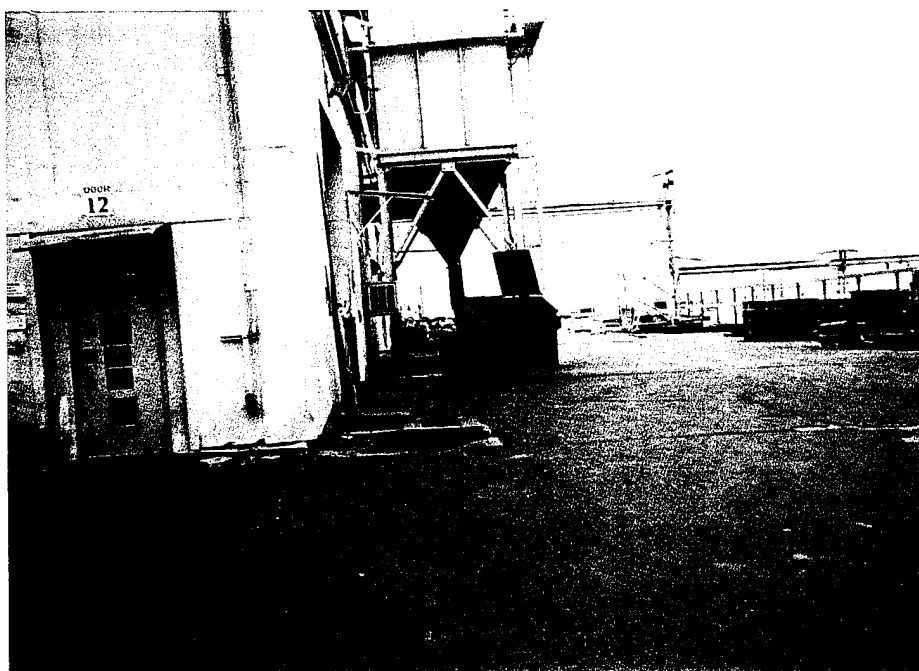
Photograph 6. (AREE 6 - SWMU 4: Sand Blast Areas). View South of Building 615 Sand Blast Grit Collection Area.

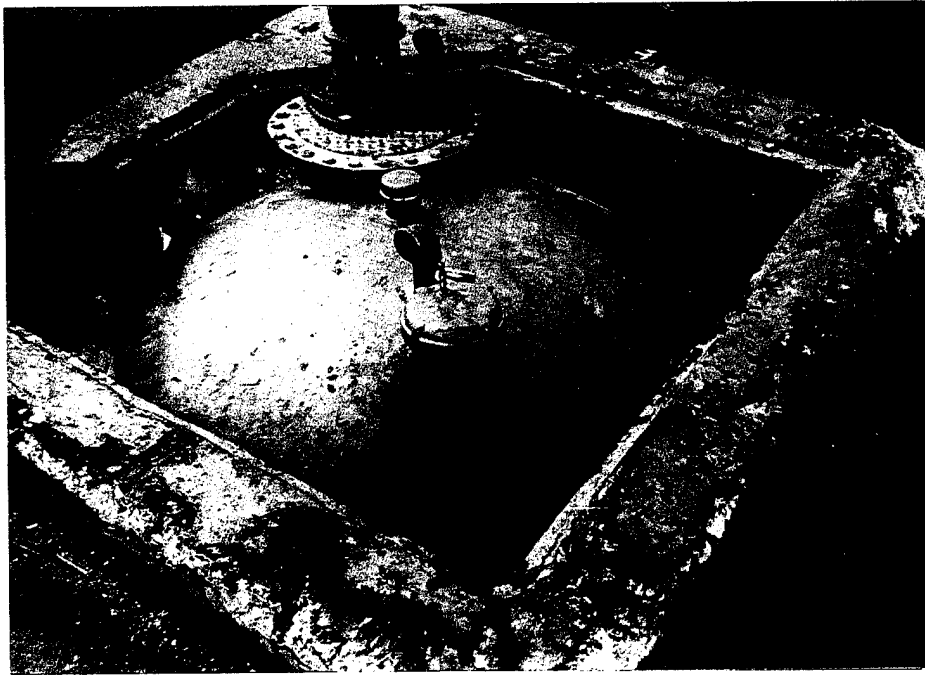
Photograph 7. (AREE 7 - SWMU 46: Waste Oil Dumpsters/Storage Tanks).  
View of Used Oil Tank at the North End of Building 637.

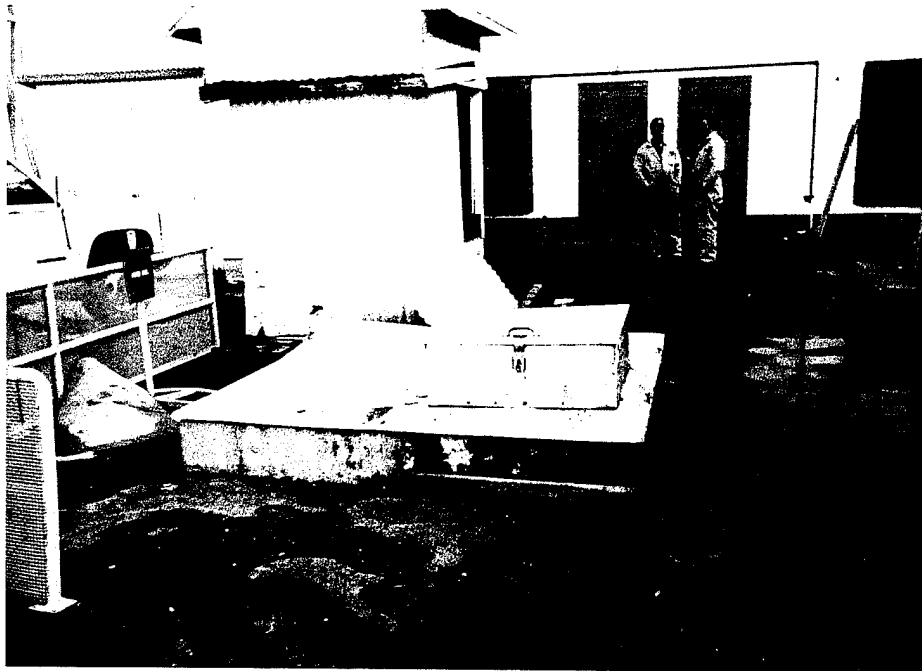
Photograph 8. (AREE 7 - SWMU 46: Waste Oil Dumpsters/Storage Tanks).  
View of Underground Used Oil Tank at the South End of Building 637.

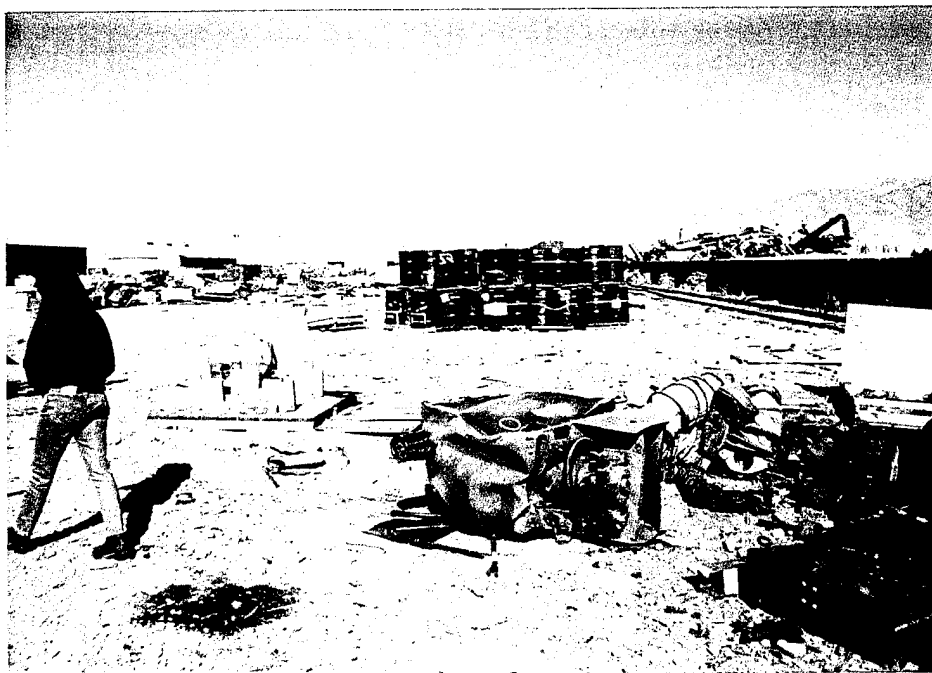
Photograph 9. (AREE 8 - SWMU 26: Defense Reutilization and Marketing Office Area). View North of the Defense Reutilization and Marketing Office Yard.

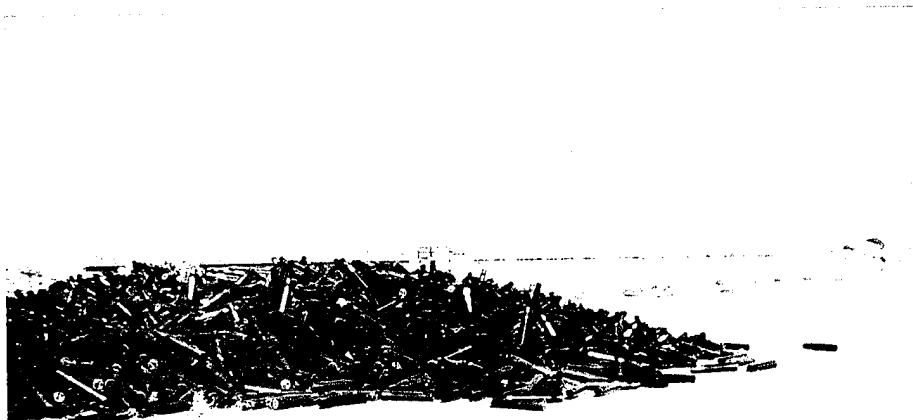
Photograph 10. (AREE 8 - SWMU 26: Defense Reutilization and Marketing Office Area). View North of 90mm Shell Casings Awaiting Sale in the Defense Reutilization and Marketing Office Yard.

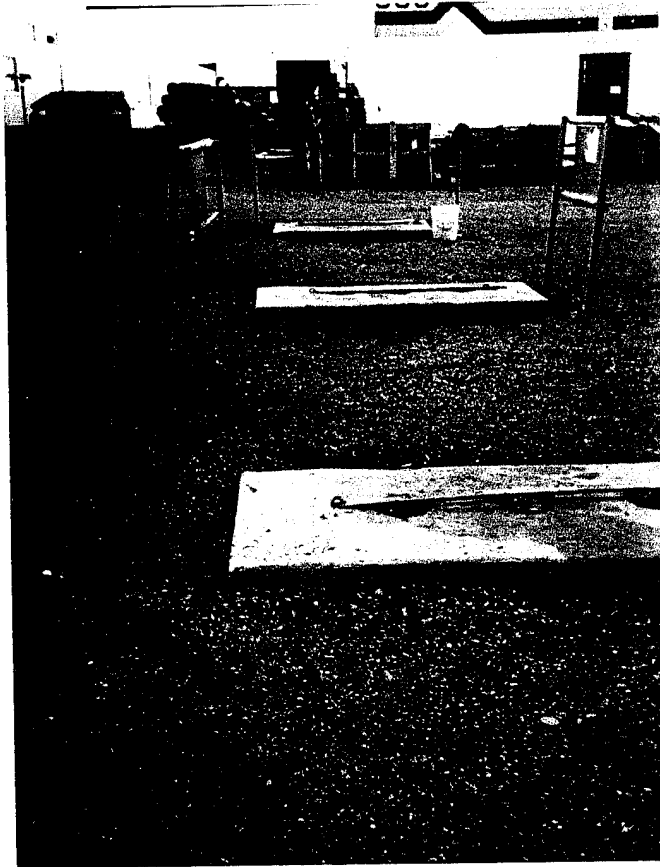
Photograph 11. (AREE 12 - Underground Storage Tanks). View South of Three Underground Storage Tanks Adjacent to Building 606.

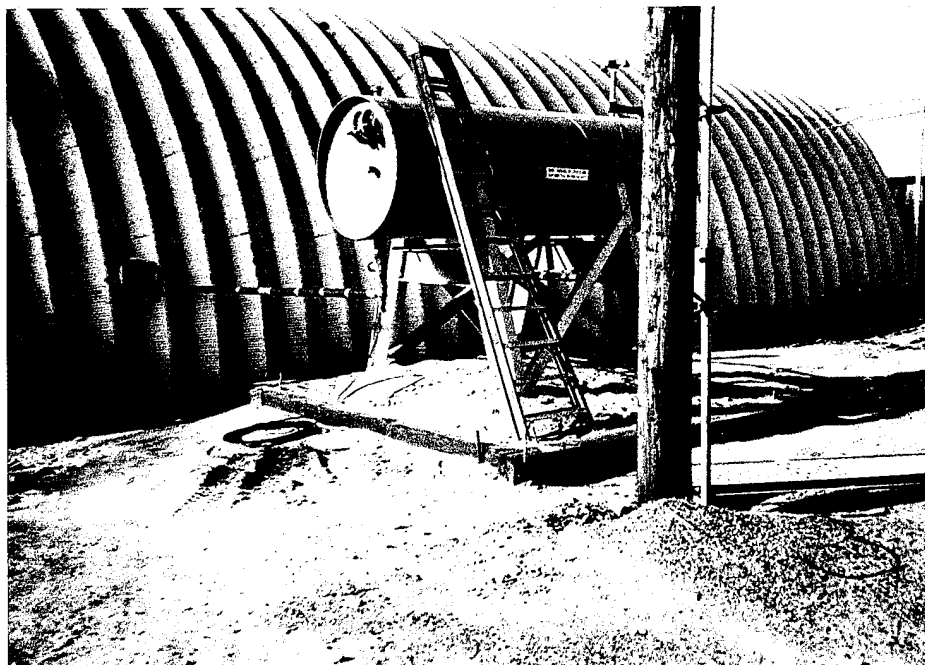
Photograph 12. (AREE 13 - Above Ground Storage Tanks). View Southwest of 1,500-Gallon Above Ground Diesel Storage Tank with Staining at the Base Adjacent to the Building on Open Storage Lot 655-5.

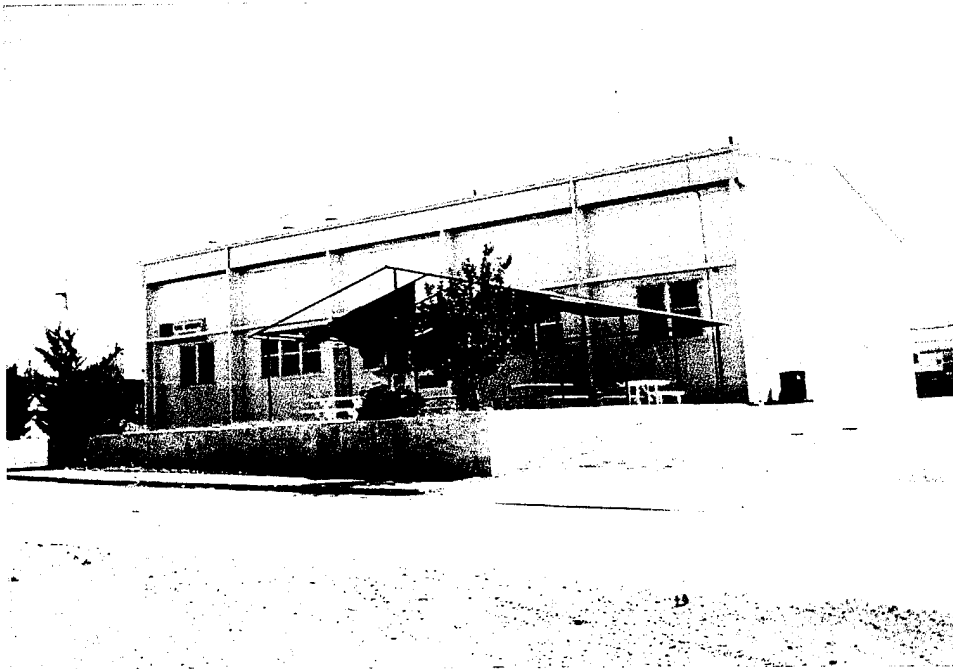
Photograph 13. (AREE 15 - SWMU 55: Battery Shop). View of the Former Location of the Battery Shop in Building 618.

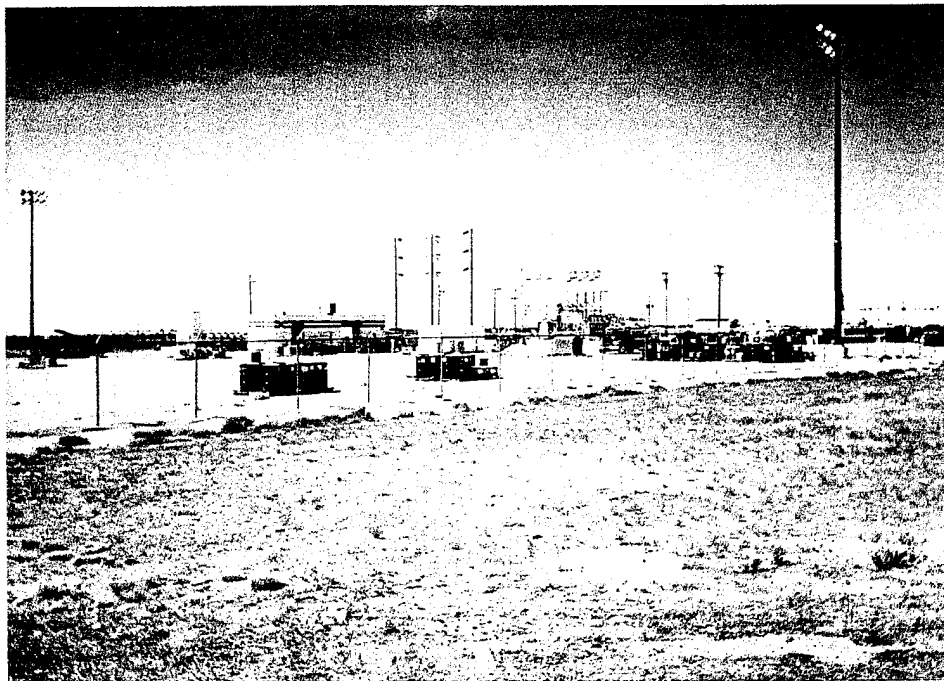
Photograph 14. (AREE 16 - SWMU 28: 90-Day Drum Storage Area). View Towards the Northwest of the 90-Day Drum Storage Area.

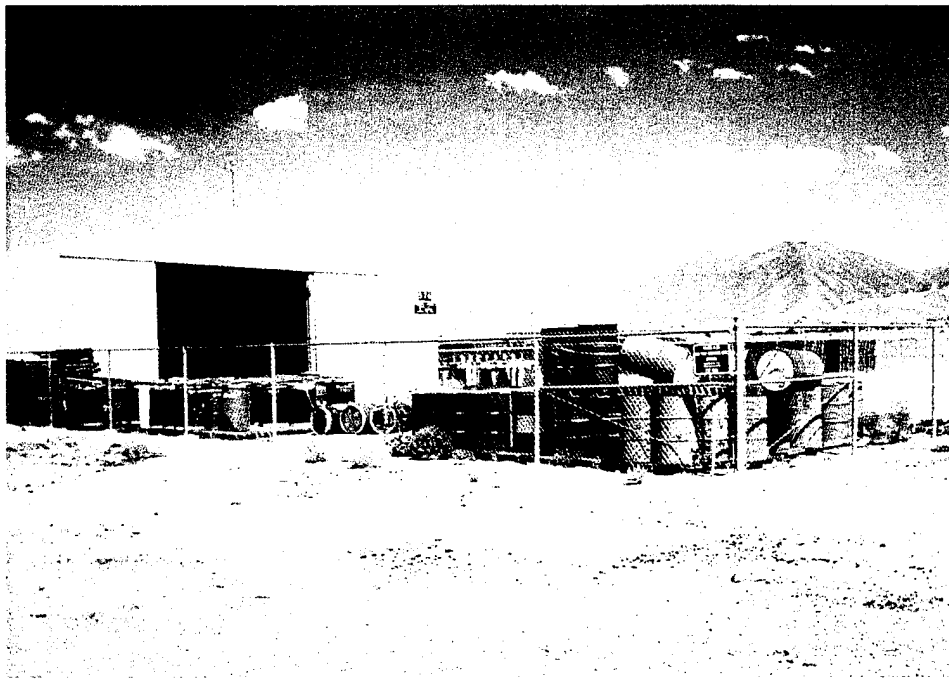
Photograph 15. (AREE 17 - SWMU 29: Drum Storage Areas). View to the Northeast of the Drum Storage Areas.

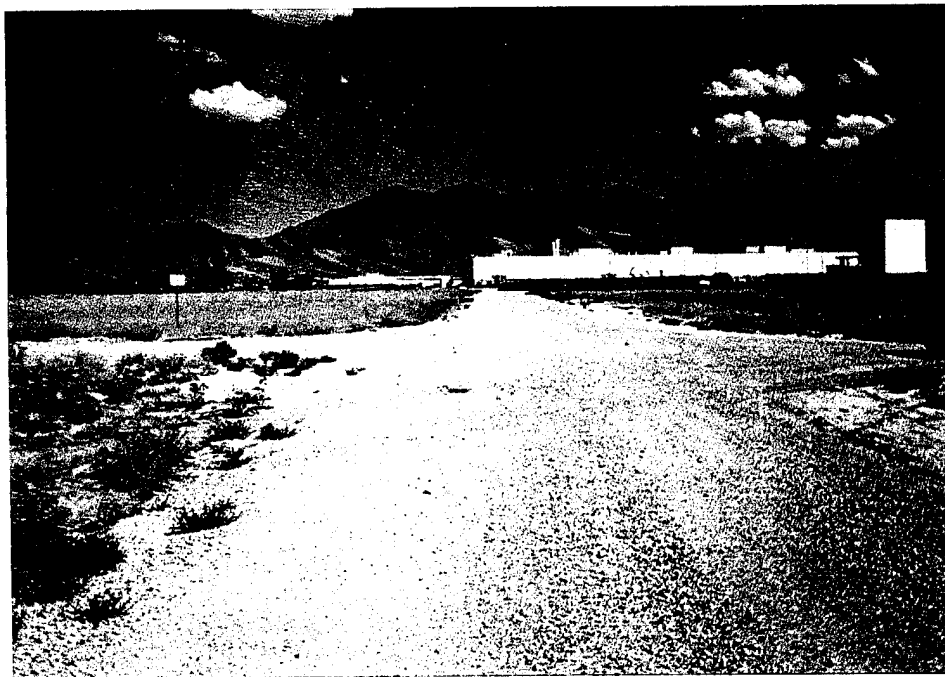
Photograph 16. (AREE 18 - SWMUs 2 and 30: Conveyance Ditches and Lagoons). View to the Southeast of the Location of a Former Drainage Ditch Along Avenue E.
